Village of Brewster Blight Determination Study

Prepared for:
Village of Brewster
50 Main Street,
Brewster, New York

Prepared by:
Ferrandino & Associates Inc.
Planning and Development Consultants
Three West Main Street, Suite 214
Elmsford, New York

November 2011

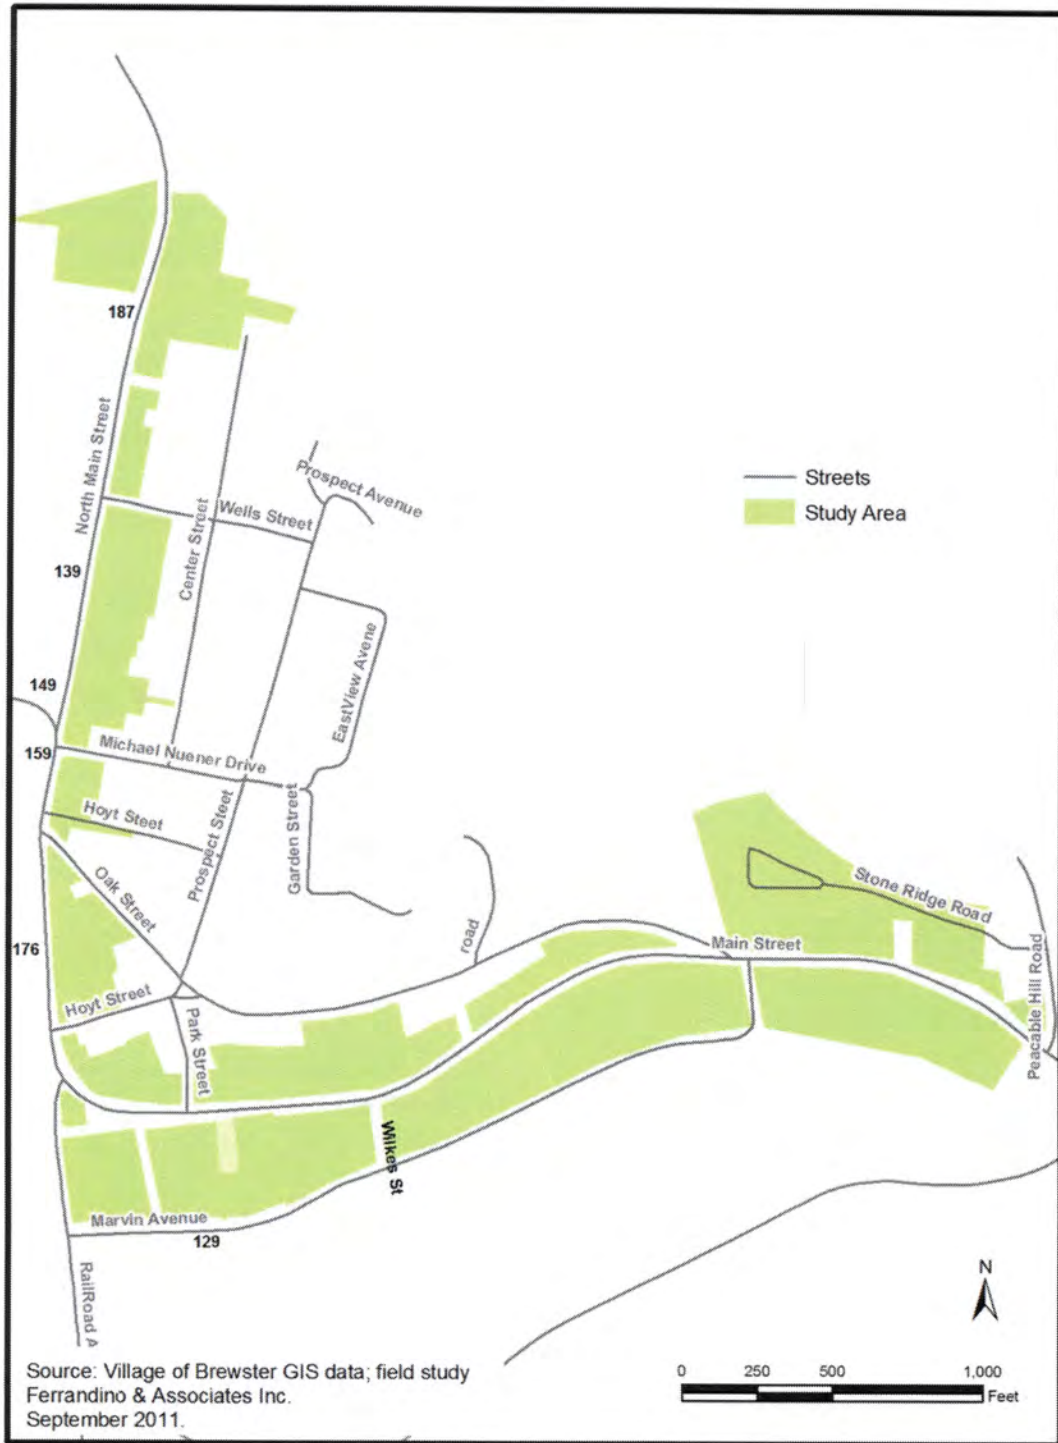
Figure 1: Blight Determination Study Area

Pursuant to its Comprehensive Plan vision of a more densely urbanized, mixed-use and pedestrian and transit-oriented Village Center¹, the Village of Brewster Board of Trustees voted to prepare a blight study for anticipated and desired development and redevelopment in a core area of the Village. The Village identified potential incidences of blight in the central downtown core and mass transit corridor (also referred to by the Village as the *Planned Action Area*), hereinafter referred to in this report as the "Study Area". The Study Area includes properties fronting on Main Street from Peaceable Hill Road to Michael Nuener Drive, both sides of North Main Street to the edge of the Village and Marvin Avenue (Figure 1).

The Consultant conducted a survey of the exterior condition of all properties within the Study Area between June and August, 2011⁴. A total of 150 properties were surveyed in the Study Area (Figure 1) and ranked according to the criteria described in *Section 1.3* of this report. The findings of the survey are discussed in the following section. The detailed data sheets for each property surveyed are included in Appendix B.

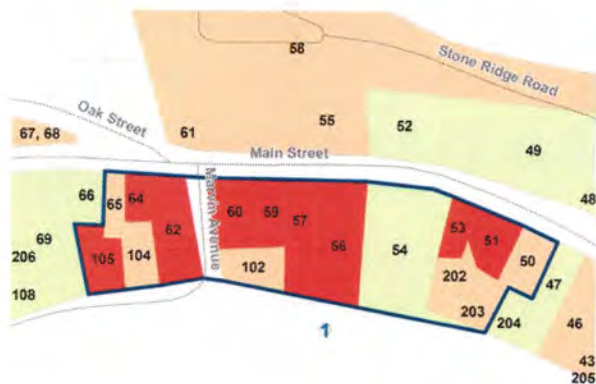
Figure 6: Potential Urban Renewal Area No. 1.

Potential Urban Renewal Area No. 1 (Figure 6) is comprised of sixteen properties, of which nine properties or 56 percent are blighted. This area has a majority of residential land uses, with a few commercial and mixed use properties, and one vacant property. With the exception of one property, all properties in this area are rated fair, or poor and blighted.

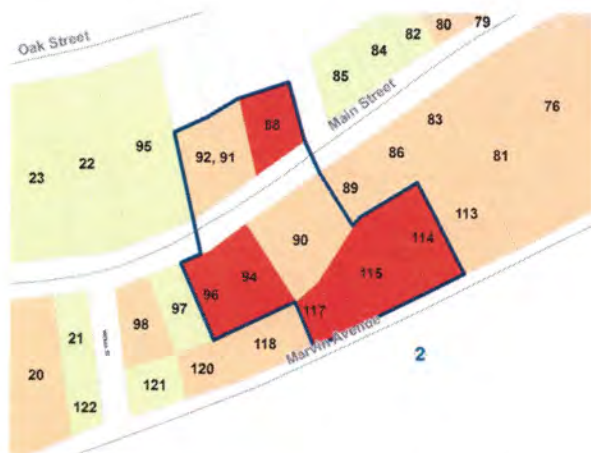
Figure 7: Potential Urban Renewal Area No. 2.

Potential Urban Renewal Area No. 2 is comprised of nine properties, of which six properties or 67 percent are blighted (Figure 7). Primary land use in this area is residential, with one light industrial use and one commercial business.

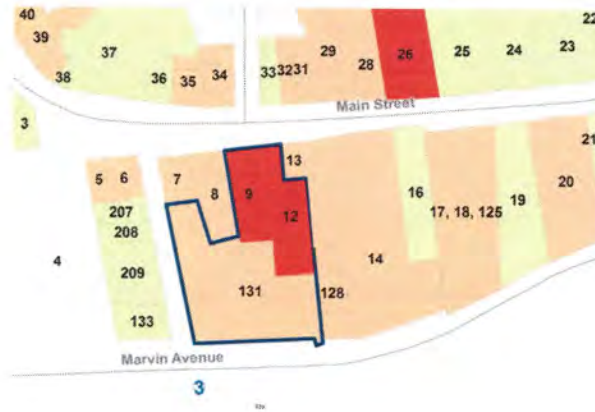
Figure 8: Potential Urban Renewal Area No. 3.

Potential Urban Renewal Area No. 3 is comprised of three properties, of which two properties or 67 percent are blighted (Figure 8). The area includes one vacant movie theatre property, one mixed use property and one residential property.

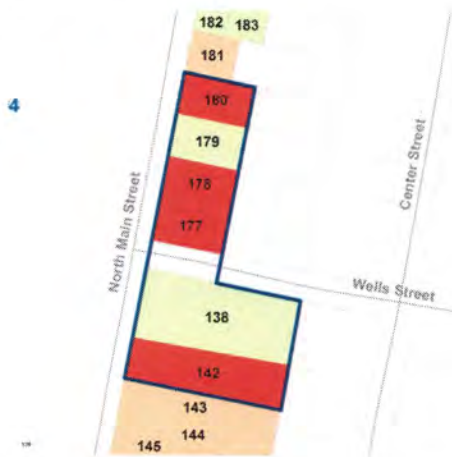
Figure 9: Potential Urban Renewal Area No. 4.

Potential Urban Renewal Area No. 4 is comprised of six properties, of which four properties or 67 percent are blighted (Figure 9). Four of the properties in this area are residential, one property is an office building and one property is a restaurant.
