# **Village of Brewster Blight Determination Study**

**Prepared for:**  
Village of Brewster  
50 Main Street,  
Brewster, New York

**Prepared by:**  
Ferrandino & Associates Inc.  
Planning and Development Consultants  
Three West Main Street, Suite 214  
Elmsford, New York

November 2011

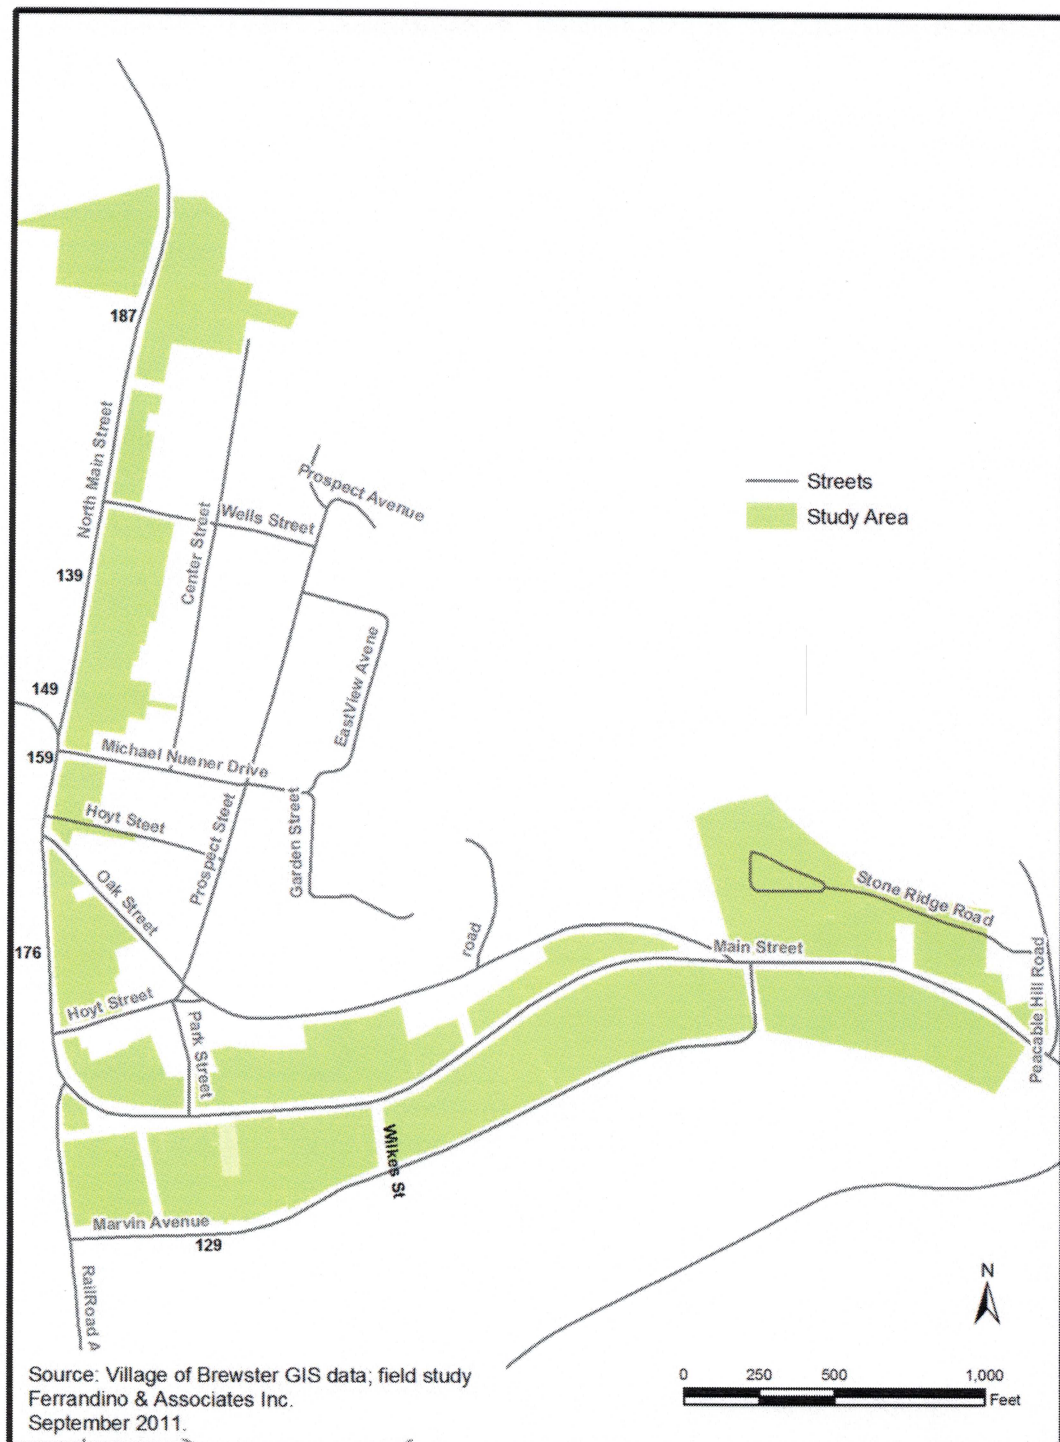
Figure 1: Blight Determination Study Area

Pursuant to its Comprehensive Plan vision of a more densely urbanized, mixed-use and pedestrian and transit-oriented Village Center<sup>1</sup>, the Village of Brewster Board of Trustees voted to prepare a blight study for anticipated and desired development and redevelopment in a core area of the Village. The Village identified potential incidences of blight in the central downtown core and mass transit corridor (also referred to by the Village as the *Planned Action Area*), hereinafter referred to in this report as the "Study Area". The Study Area includes properties fronting on Main Street from Peaceable Hill Road to Michael Nuener Drive, both sides of North Main Street to the edge of the Village and Marvin Avenue (Figure 1).

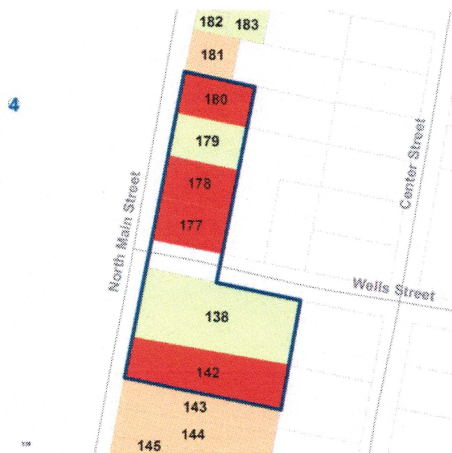
Figure 9: Potential Urban Renewal Area No. 4.

Potential Urban Renewal Area No. 4 is comprised of six properties, of which four properties or 67 percent are blighted (Figure 9). Four of the properties in this area are residential, one property is an office building and one property is a restaurant.
