## **Village of Brewster Blight Determination Study**

**Prepared for:**  
Village of Brewster  
50 Main Street,  
Brewster, New York

**Prepared by:**  
Ferrandino & Associates Inc.  
Planning and Development Consultants  
Three West Main Street, Suite 214  
Elmsford, New York

November 2011

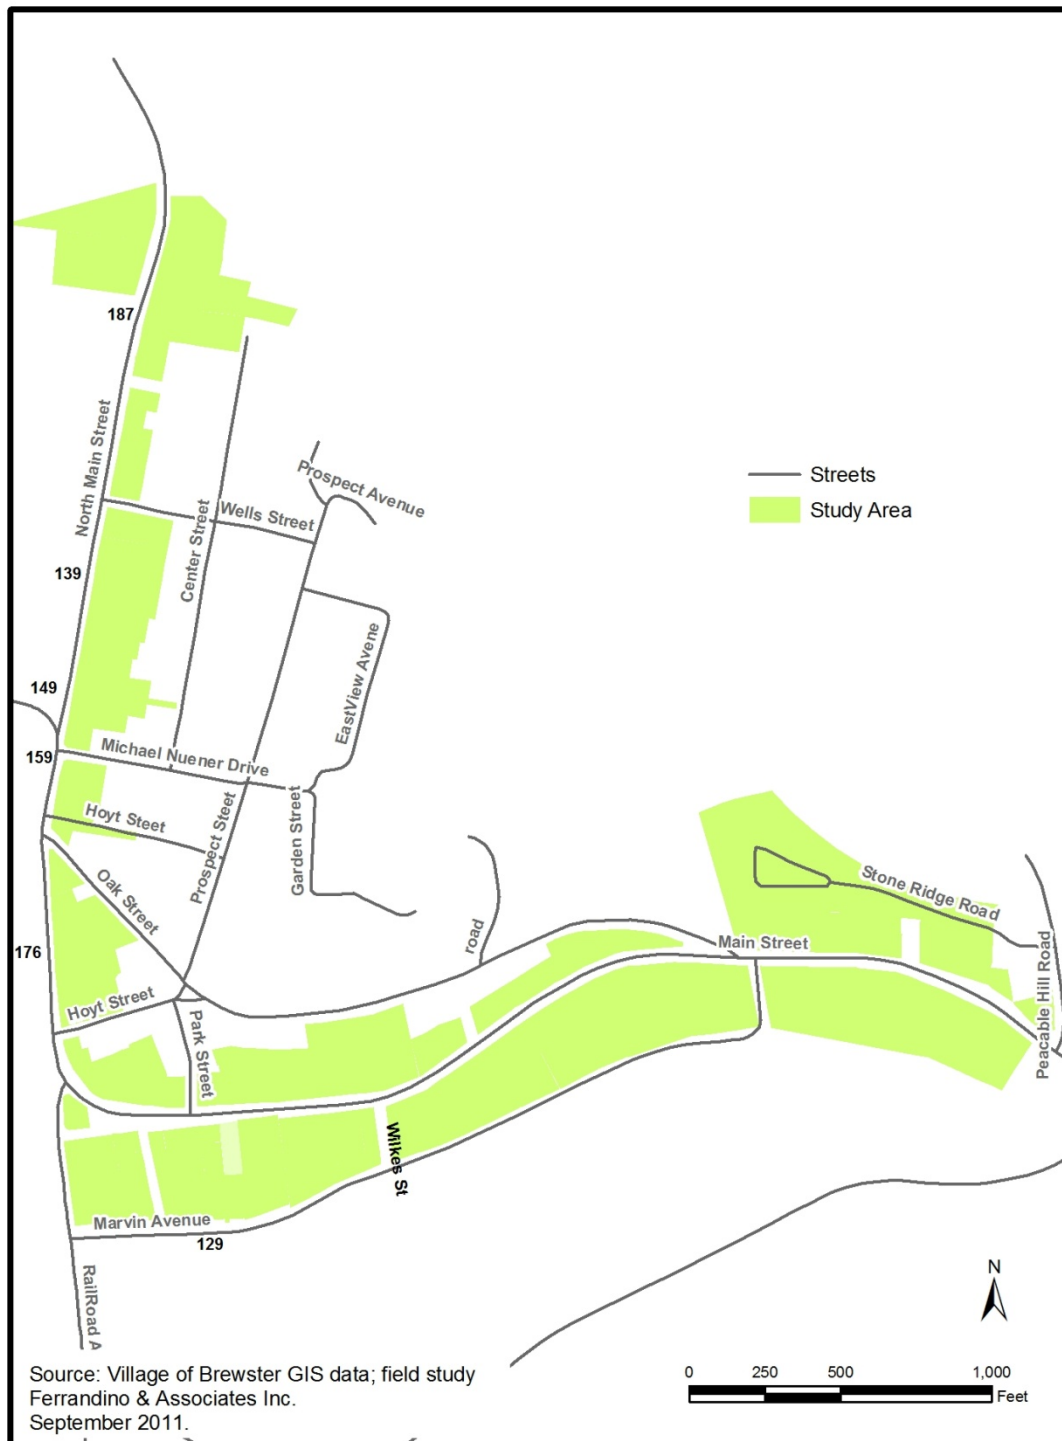
Figure 1: Blight Determination Study Area

Pursuant to its Comprehensive Plan vision of a more densely urbanized, mixed-use and pedestrian and transit-oriented Village Center<sup>1</sup>, the Village of Brewster Board of Trustees voted to prepare a blight study for anticipated and desired development and redevelopment in a core area of the Village. The Village identified potential incidences of blight in the central downtown core and mass transit corridor (also referred to by the Village as the *Planned Action Area*), hereinafter referred to in this report as the “Study Area”. The Study Area includes properties fronting on Main Street from Peaceable Hill Road to Michael Nuener Drive, both sides of North Main Street to the edge of the Village and Marvin Avenue (Figure 1).

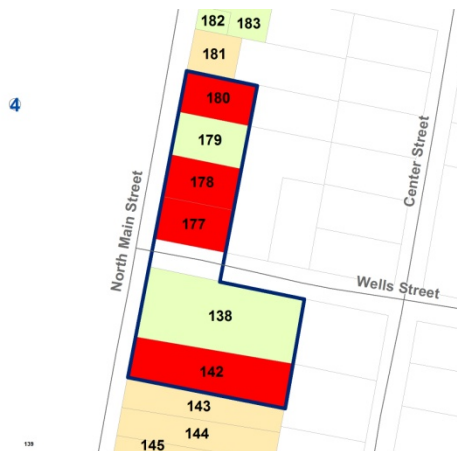
Figure 9: Potential Urban Renewal Area No. 4.

Potential Urban Renewal Area No. 4 is comprised of six properties, of which four properties or 67 percent are blighted (Figure 9). Four of the properties in this area are residential, one property is an office building and one property is a restaurant.
